OUTLINE

To provide the Argyle Town Council with a dashboard view of the urgent drainage issues facing the Skyline Park neighborhood.

SURFACE RUN OFF

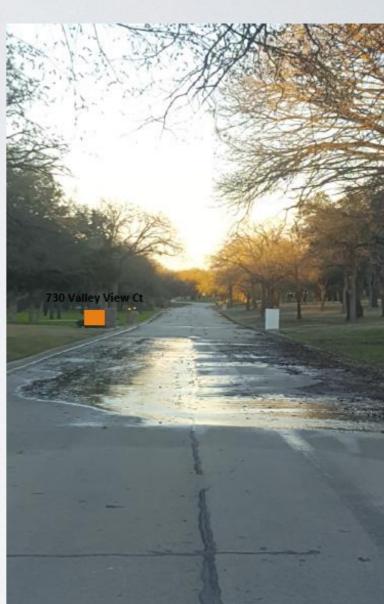
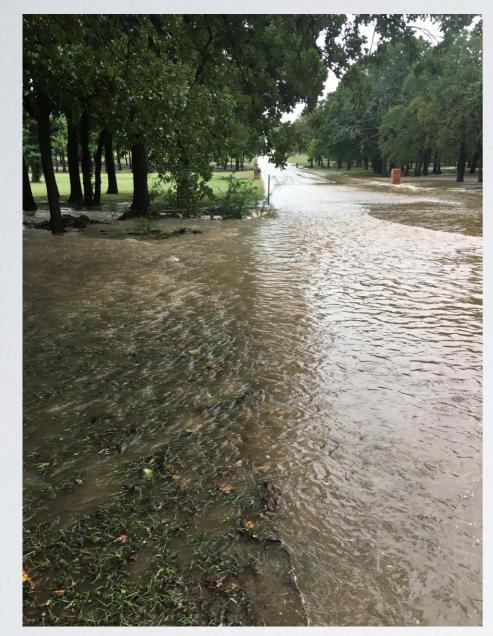
Per Google Earth: Using historical imagery, there has been standing water and debris on this portion of the road every day beginning Jan 2016.

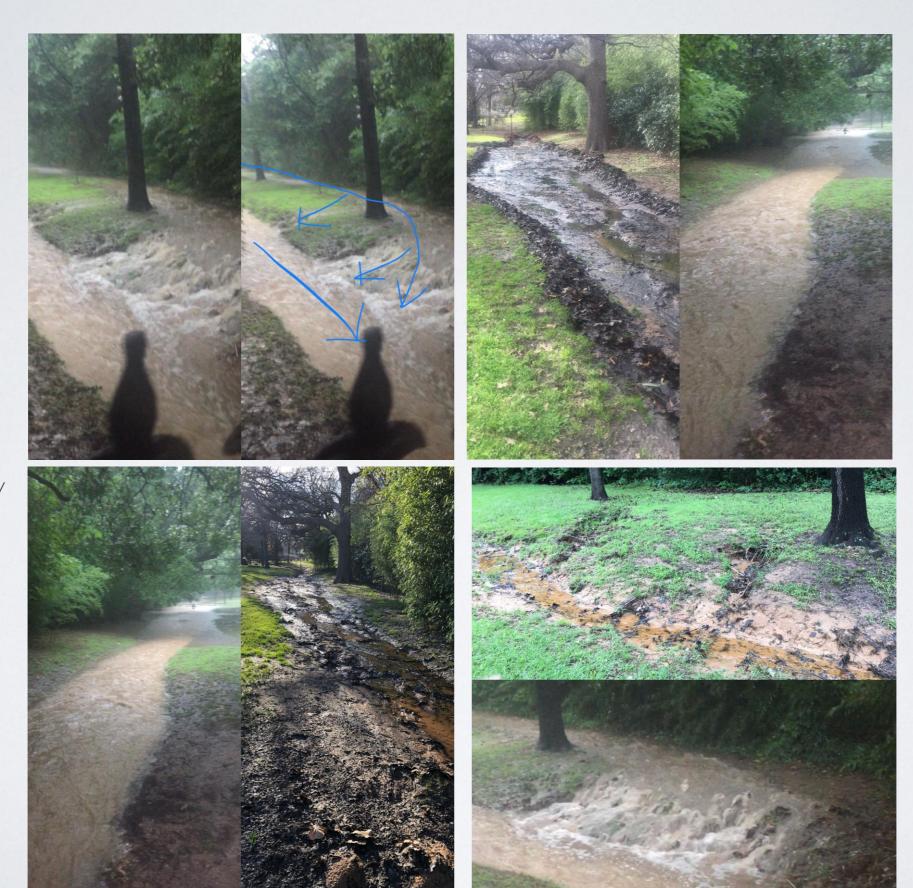
704 VALLEY VIEW

Backside of property

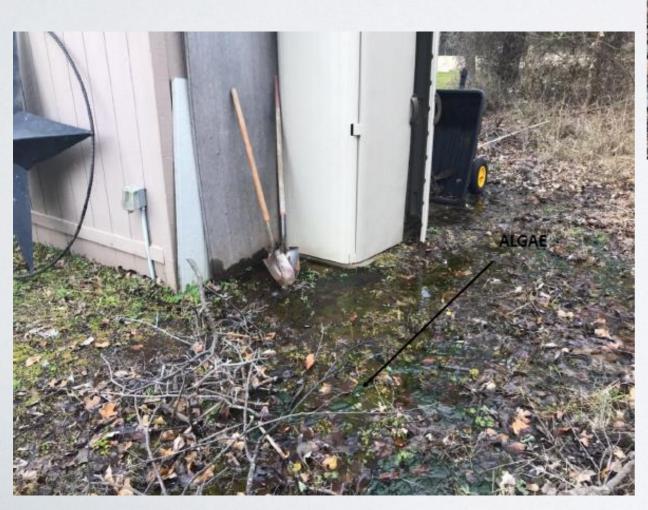
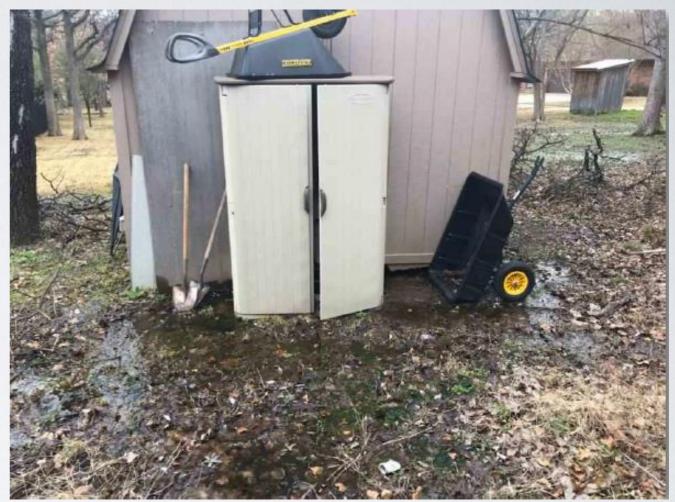
730 VALLEY VIEW

Shed (with electricity) sitting in 2-3" of water at all times.

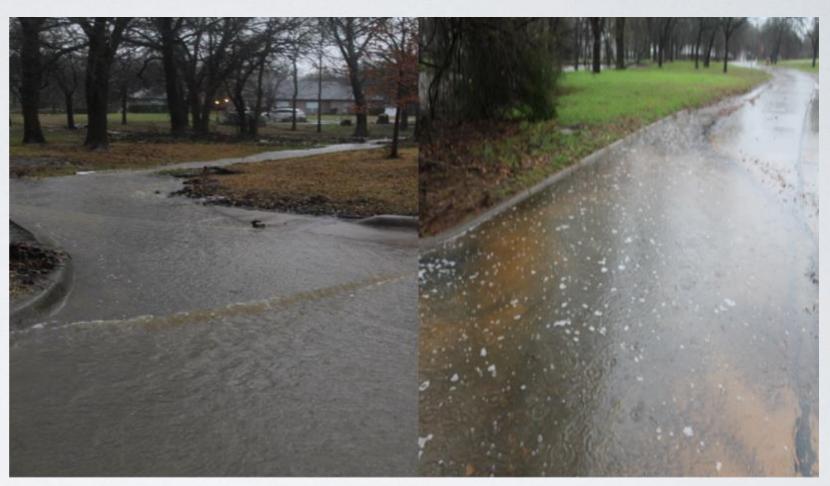
Water is channeled across the street to the North side of Valley View

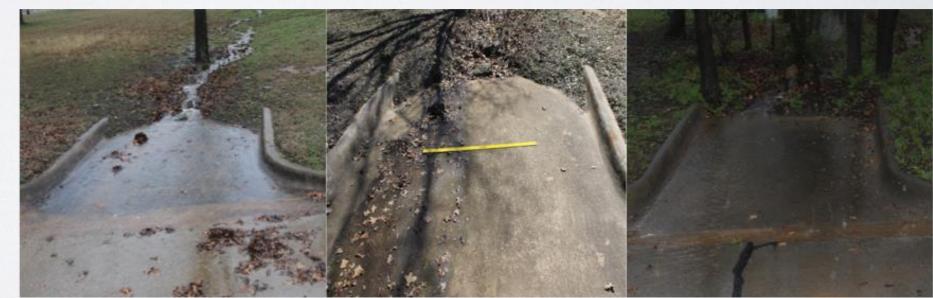
In lieu of bar ditches on the south side of Valley View there are three 9' curb cuts draining directly onto Valley View

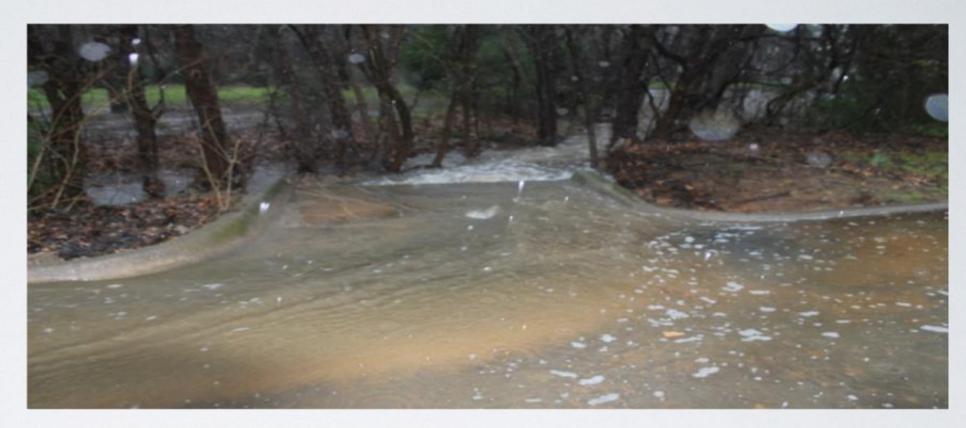
All Valley View runoff flows to a pond at Skyline and Valley View

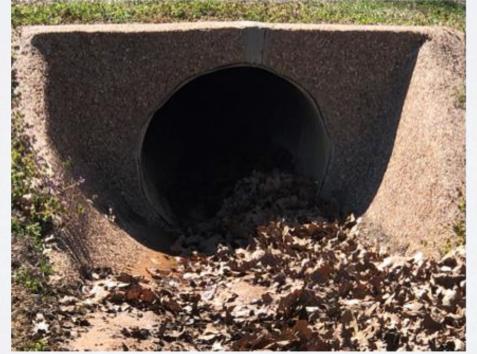
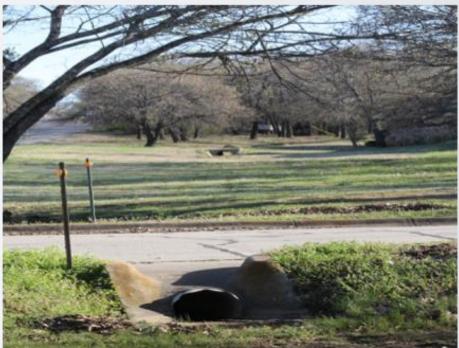
A bar ditch on Skyline crosses under Valley View flowing to the same pond Valley View drains into

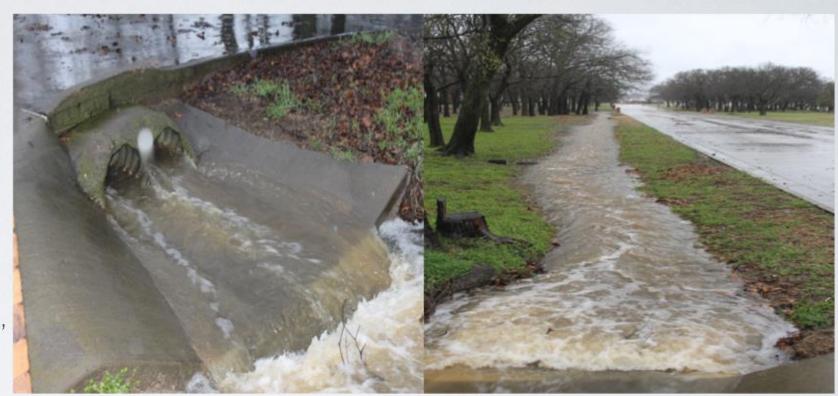
From the pond, two culverts empty into a bar ditch on the west side of Skyline

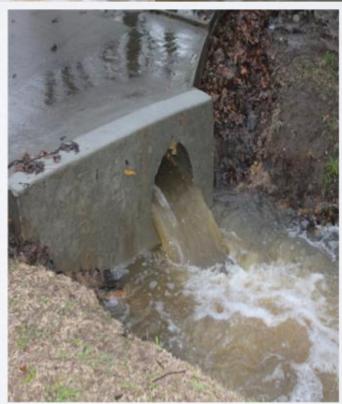
The bar ditch now hits a single 18" culvert before turning under Skyline.

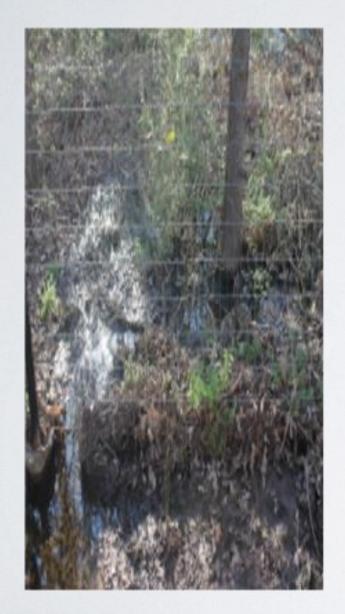
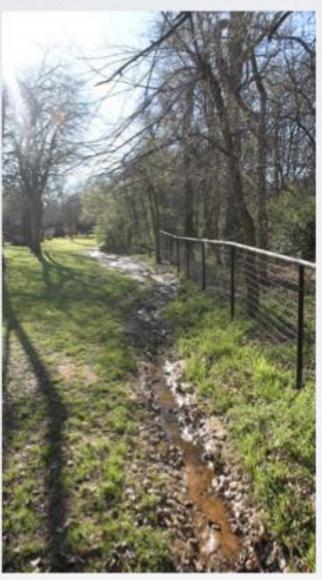
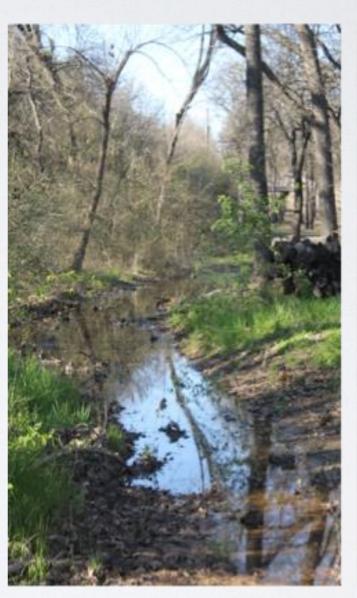
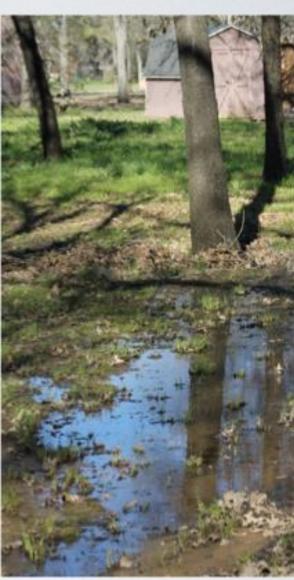
A new and substantial drainage ditch has formed along the abandoned equestrian, utility and 100 year laminar flow easements behind homes on the north side of Valley View. The new flows are flooding the backyard at 905 Skyline

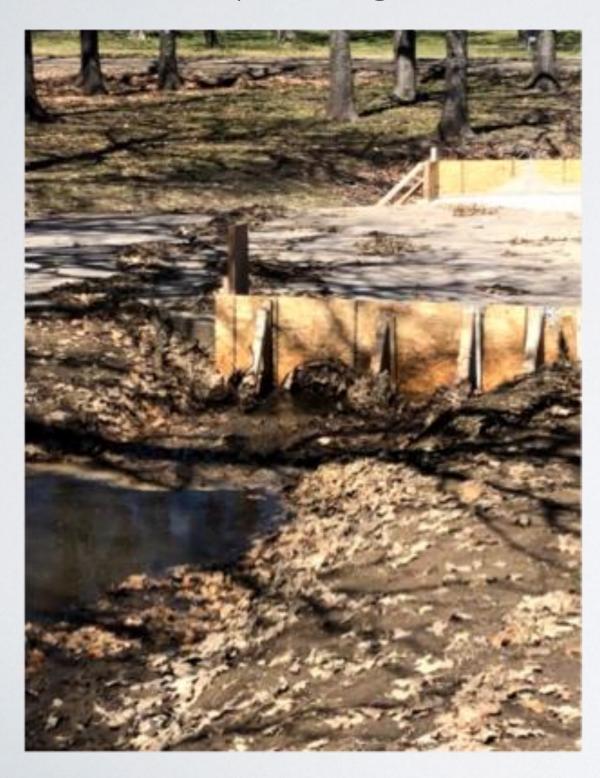
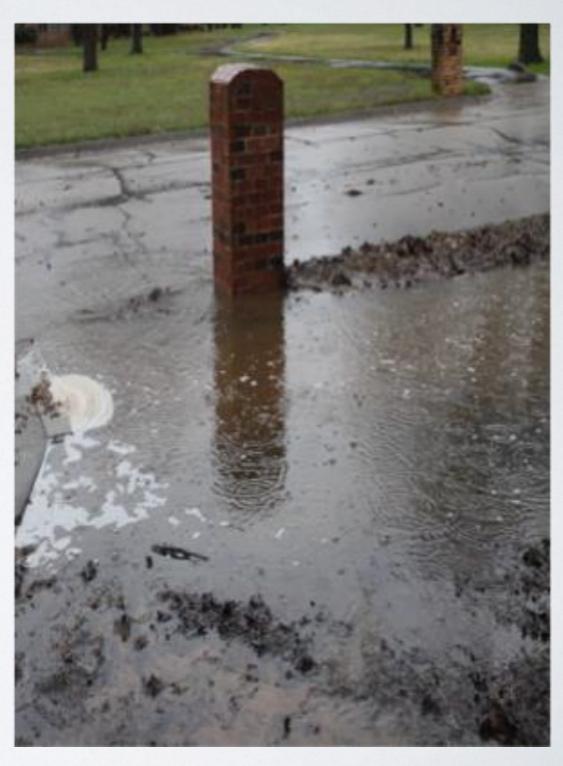
Repair Design

All of Skyline and Valley View bar ditches drain into the recently "repaired" and now a single 18' culvert
